1. INTRODUCTION

This Inspection Report includes findings and observations concerning the National Pollutant Discharge Elimination System (“NPDES”) Stormwater Inspection (“Inspection”) conducted by José A. Rivera, Lead Environmental Engineer, Clean Water Act Team (the “EPA Inspector”), of the United States Environmental Protection Agency’s (“EPA”) Caribbean Environmental Protection Division (“CEPD”) at the Aguadilla Pier, Corp. (“Aguadilla Pier” or “APC”) property located in Aguadilla, Puerto Rico (the “Site” or “Property”). **Image 1** (below) depicts an aerial imagery of the Site found in Google Earth Pro™, with imagery dated June 11, 2017.

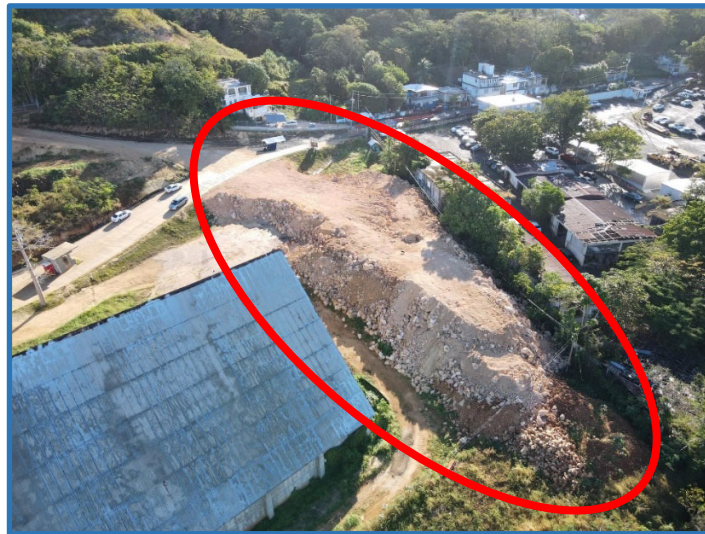
Image 4

- a. The building up of the stockpile located south of the Warehouse Building began on or about September 2022. **Image 4** (below: red-colored ellipse) and **Image 5** (next page: red-colored quadrangle) depict the stockpile from two aerial views.⁹

Perimeter controls were not installed for the stockpile (logs and silt fences), which are controls identified and selected in Part 4.4 of the Site WPPP. Also, the top of stockpile was not covered with vegetation for stabilization, which is another control identifies and selected in Part 4.4 of the Site SWPPP.

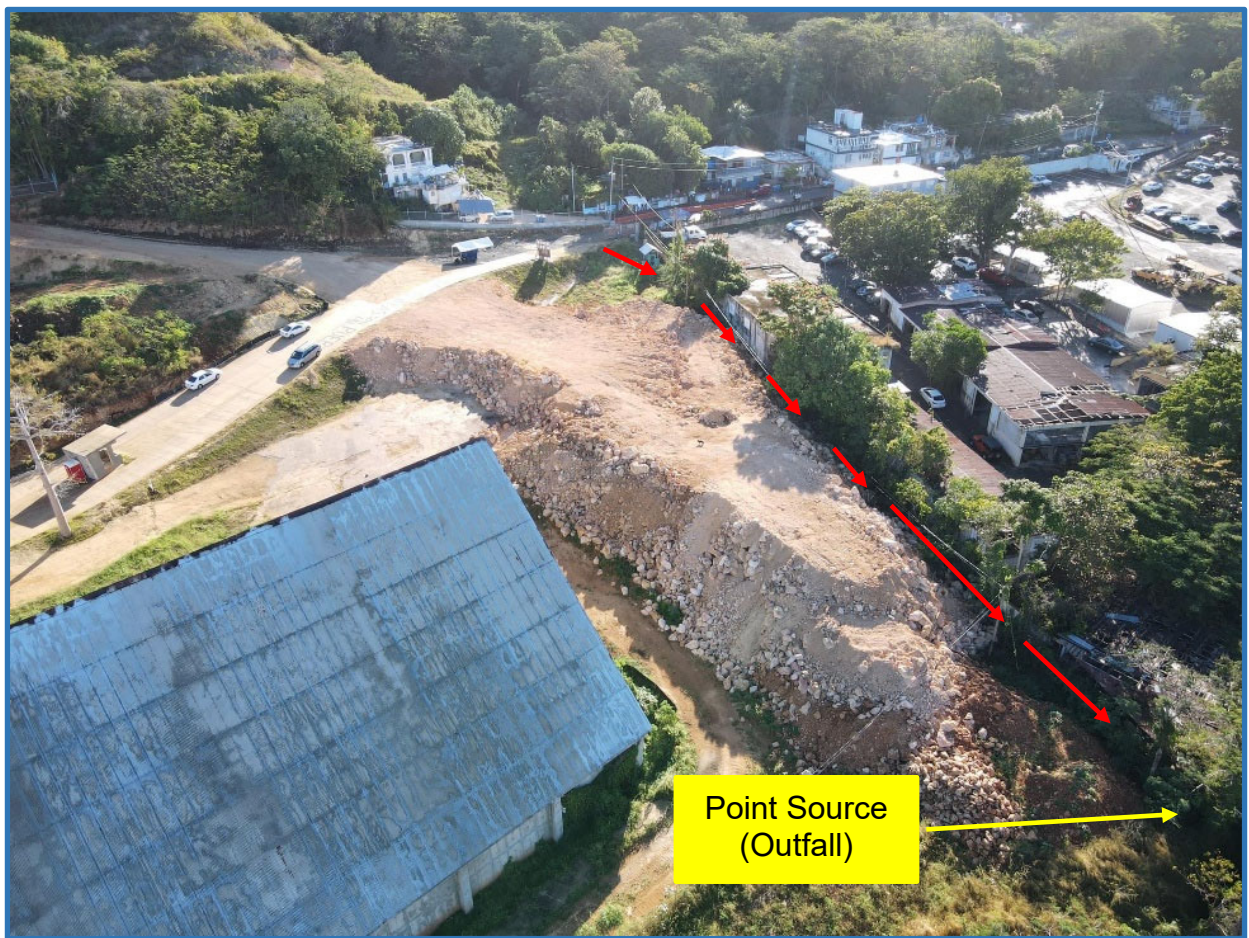
Image 7

- n. The soil in the north and northern areas of the Site had been disturbed.
- o. A dirt road located on the northeast area of the Site remains and is used for construction equipment access between the Site and the The Cliff site.
- p. A dirt road located along the east side of the site does not have any soil stabilization practice and dust controls.
- q. Storm water run-on from areas beyond the east boundary of the Site will flow into the dirt road described in Section 11.p of this Inspection Report. Storm water management controls to deviate these flows were not observed.
- r. Two additional point sources were observed and identified. **Image 7** (below) and **Picture 20** (Attachment 4) depict the approximate locations for both points sources.¹⁰

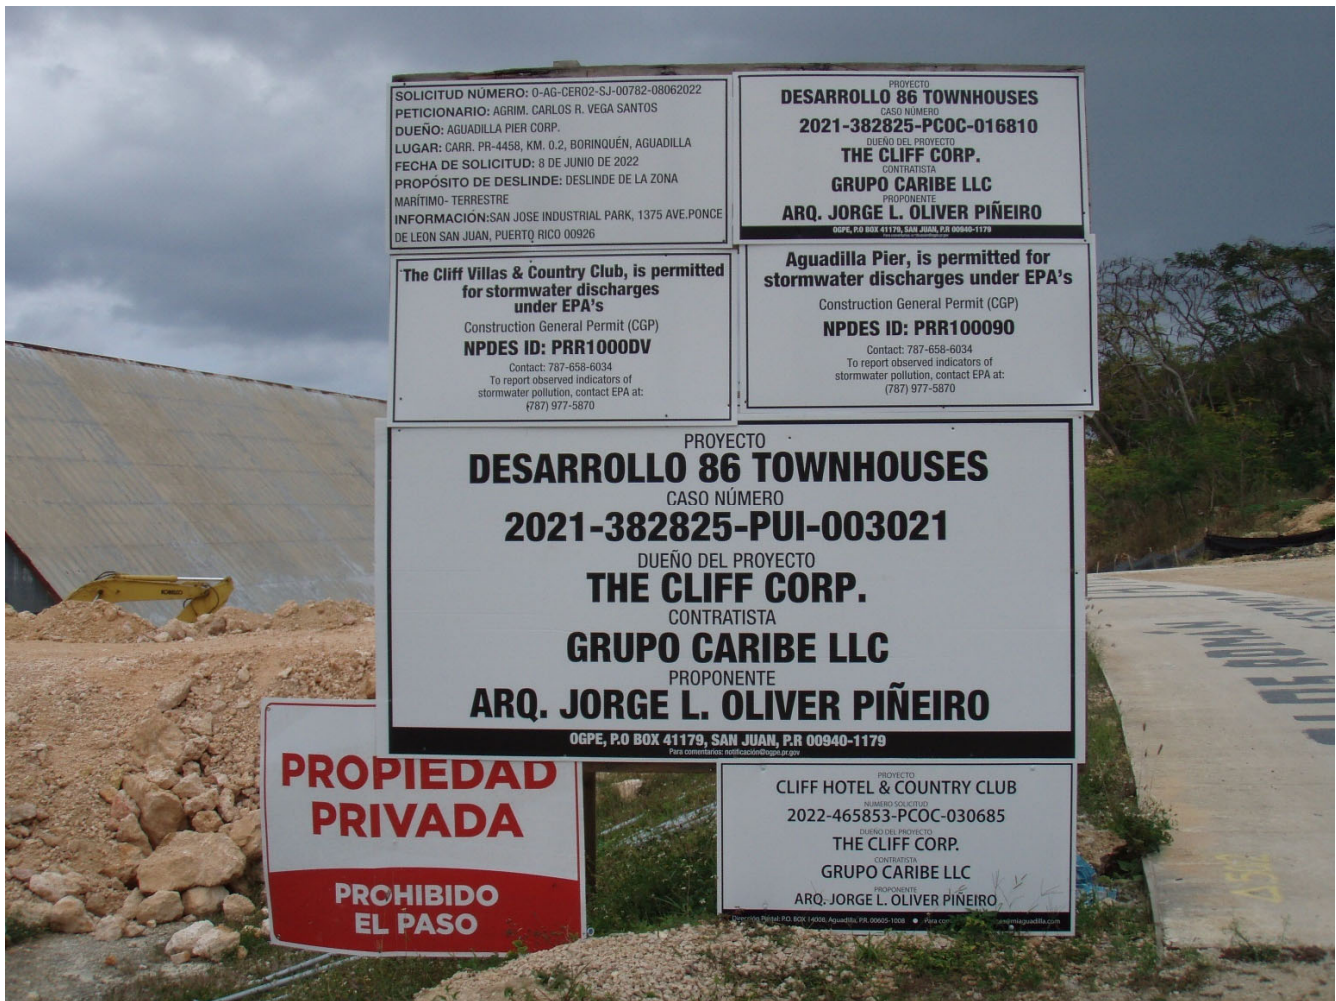
Picture 1
(Nikon Camara: P2221341.JPG; 2/23/23; 10:36 a.m.)

- ✚ This picture depicts several signs including NPDES ID under the 2022 CGP.
- ✚ This picture also depicts the main access roads to the center areas of Site.

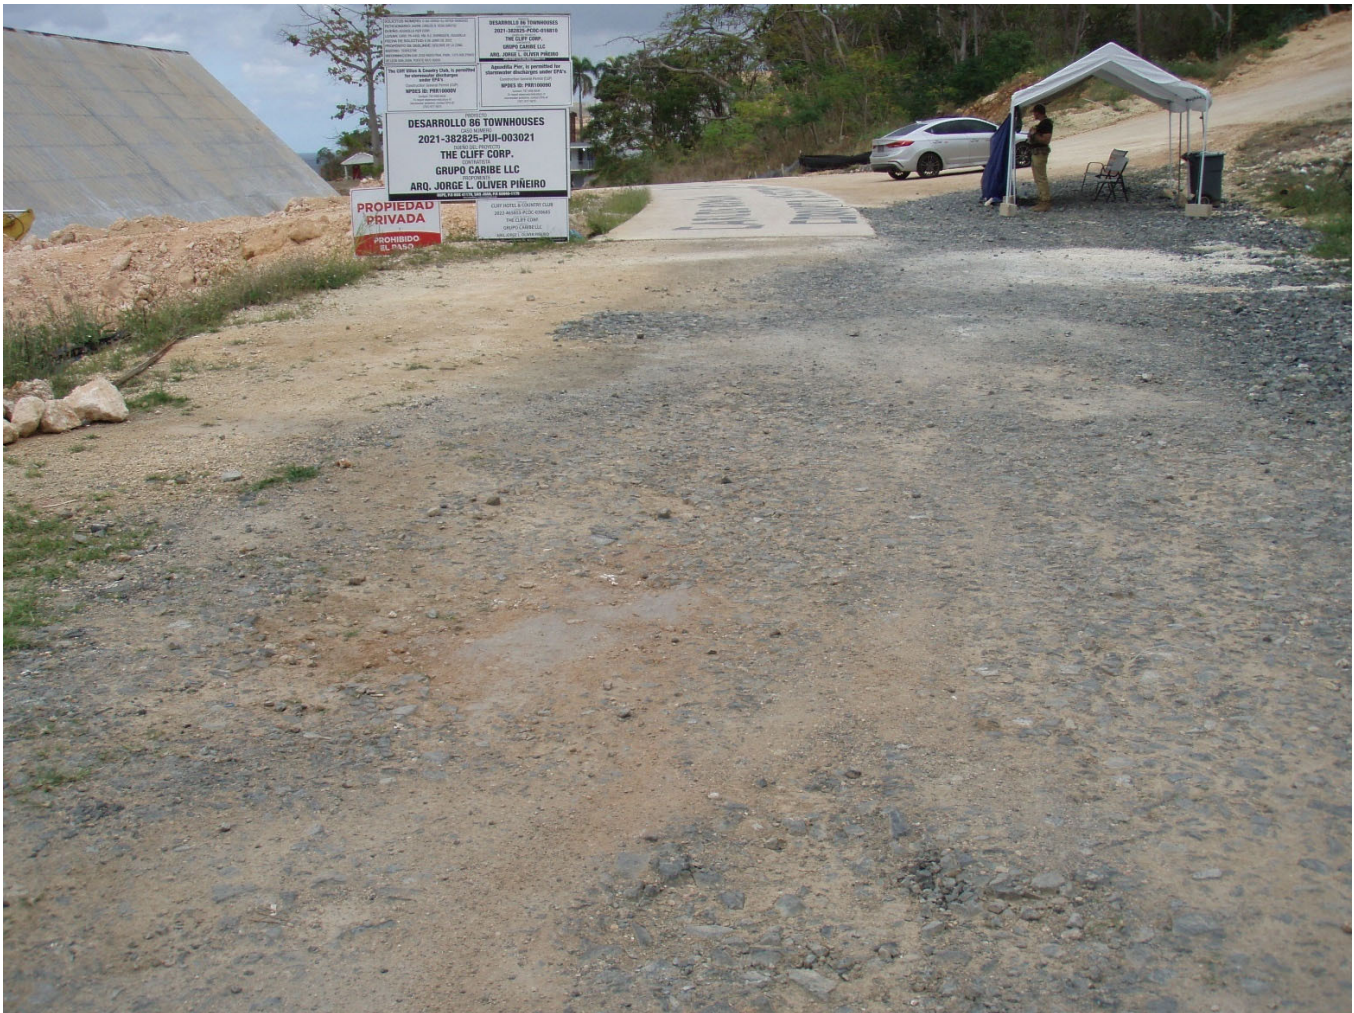
Picture 2
(Nikon Camara: P2221340.JPG; 2/23/23; 10:35 a.m.)

- ✚ This picture depicts the entrance and exit on the south boundary of the Site.
- ✚ As stated in the Inspection Report, the control measure (crushed stone) for this entrance has not been maintained and does not meet the requirements of the 2022 CGP.

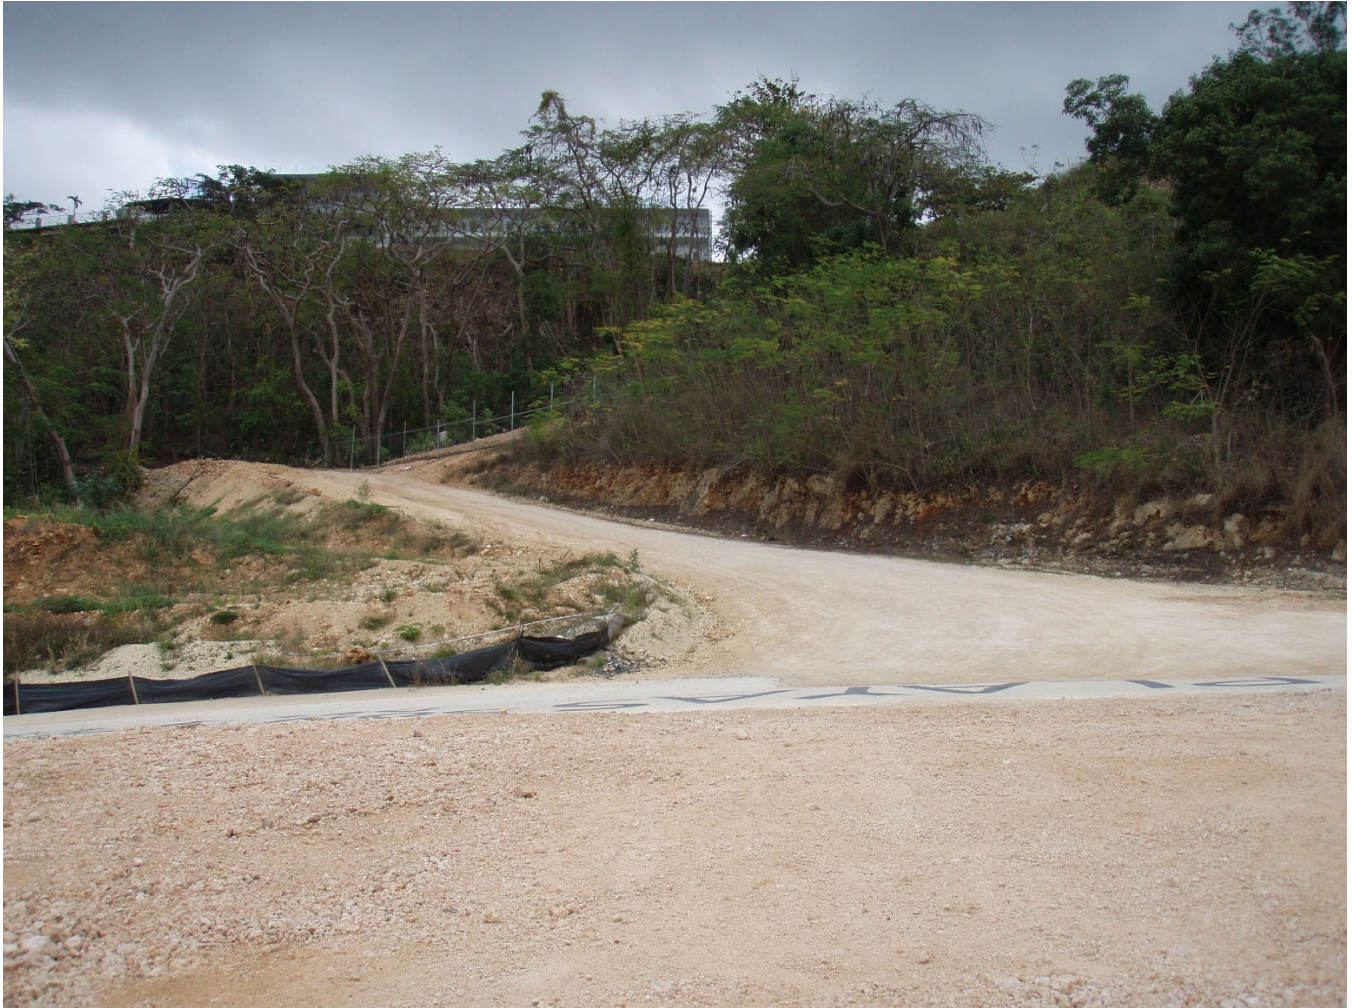
Picture 3

- ✚ This picture depicts areas near the entrance and exit of the Site.
- ✚ The dirt road at the center of this picture depicts the road to be widened along the east boundary of the Site, which it is also the main access to the The Cliff site. The dirt road does not have soil stabilization.
- ✚ The silt fence depicted in this picture is deteriorated.
- ✚ The other areas depicted in this picture lacked soil stabilization.

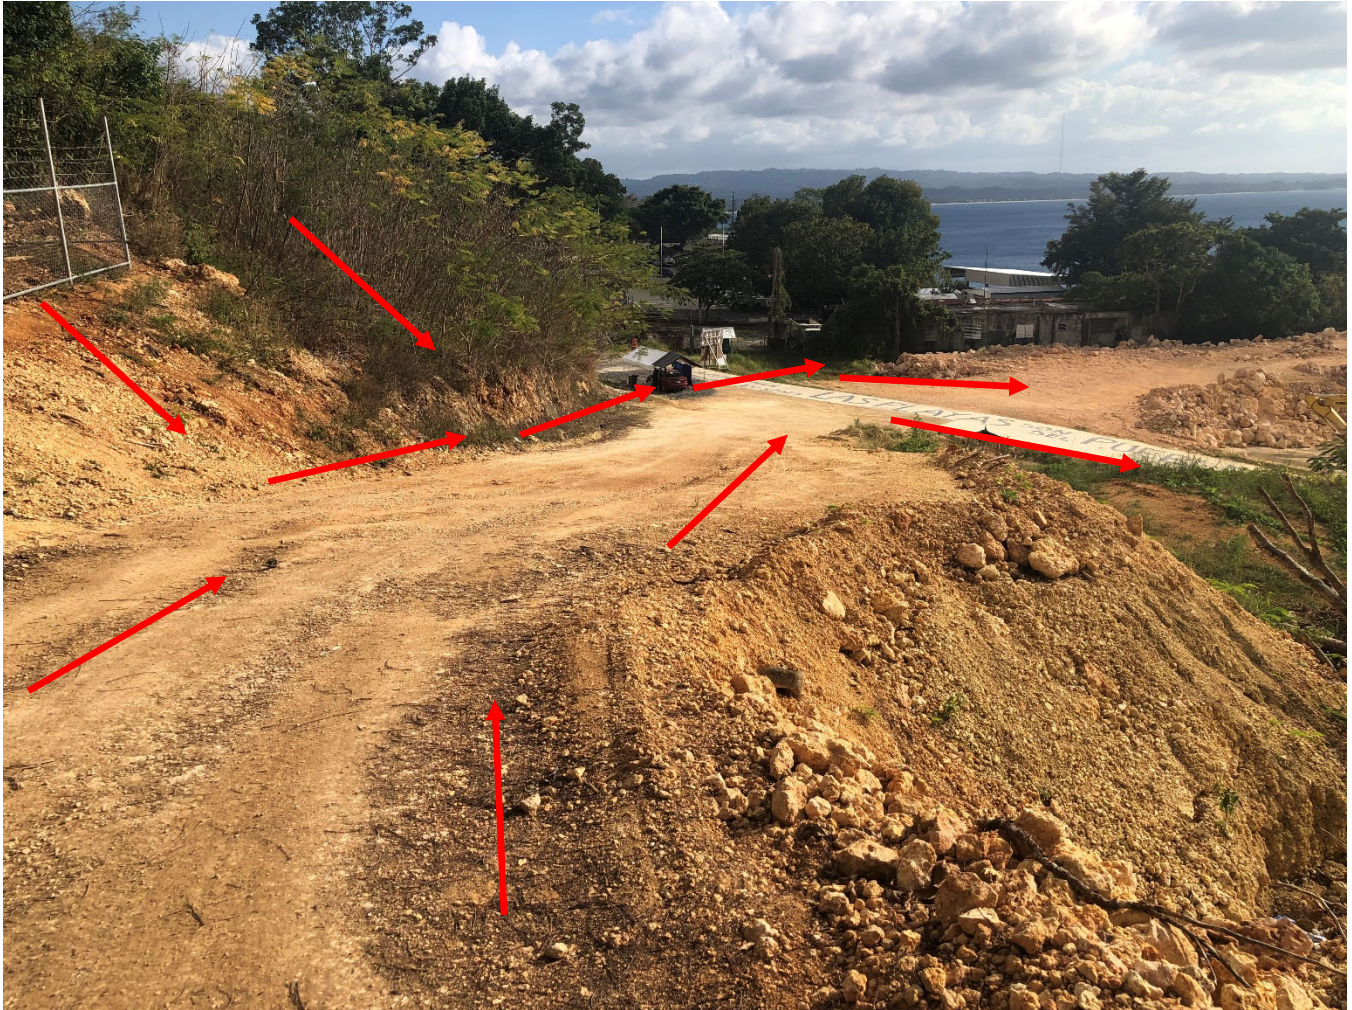
Picture 4
(Iphone 8+: IMG_5686.JPG; 2/23/23; 4:30 p.m.)

- ✚ This picture depicts a segment of the dirt access road located along the east perimeter of the Site. Particularly, this picture shows its connection to the main entrance of the Site.
- ✚ This dirt access road lacked soil stabilization.
- ✚ Storm water run-on from areas east of the Site flows into the Site. Storm water management controls were not implemented to manage such run-on flows away from exposed soils.
- ✚ The red-colored arrows depict the runoff path.

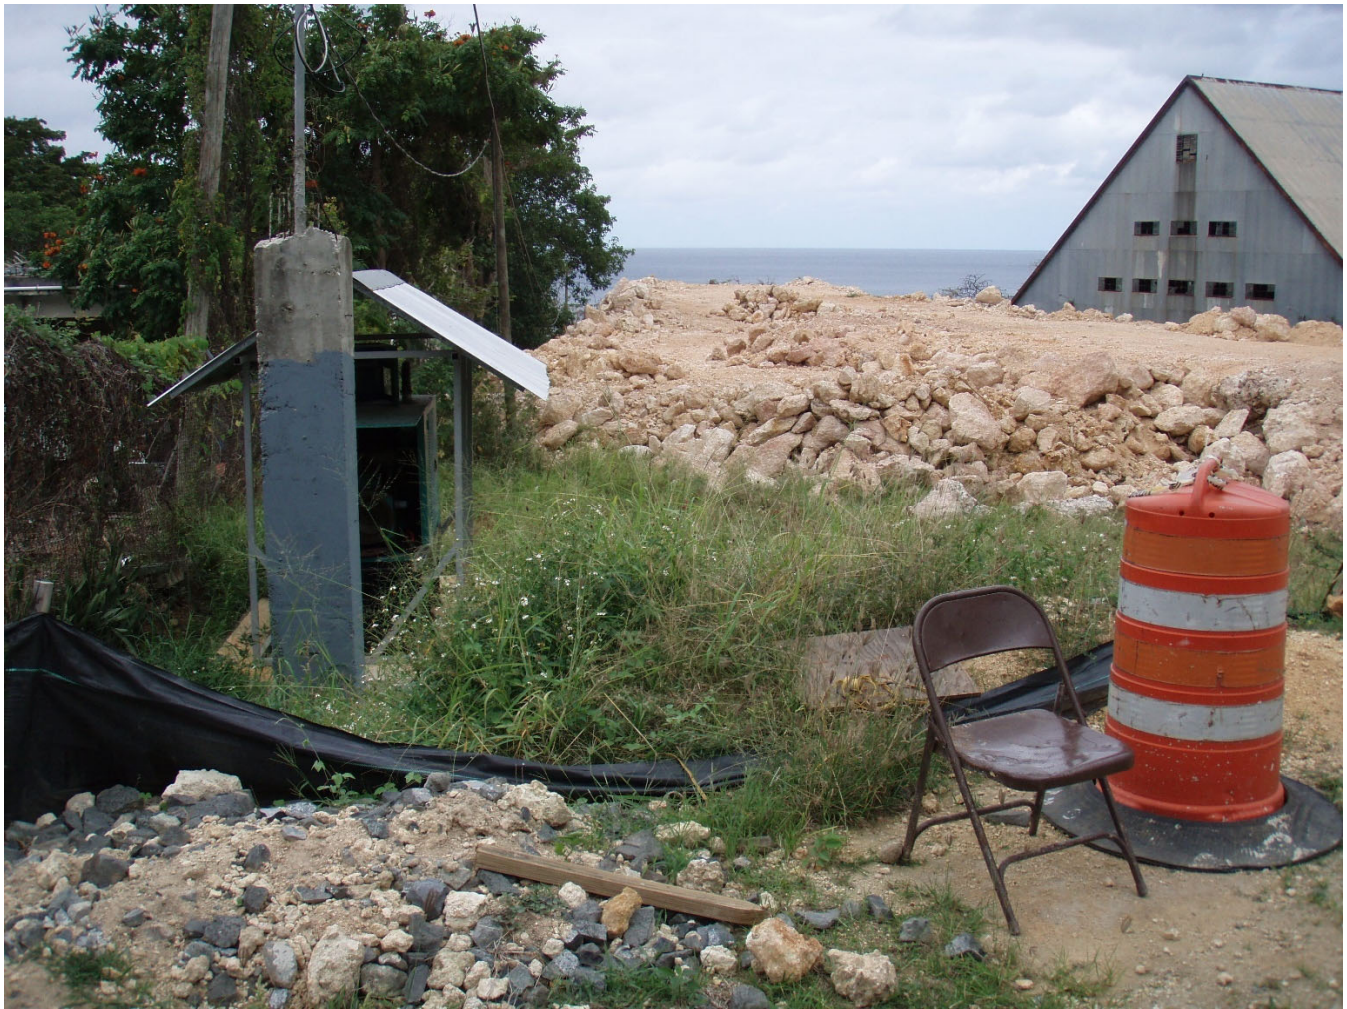
Picture 4
(Nikon Camara: P2221339.JPG; 2/23/23; 10:35 a.m.)

- ✚ This picture mainly depicts the south boundary of the Site and the soil stockpile located south of the Warehouse Building.
- ✚ The silt fence was deteriorated.
- ✚ No perimeter controls for the stockpile.

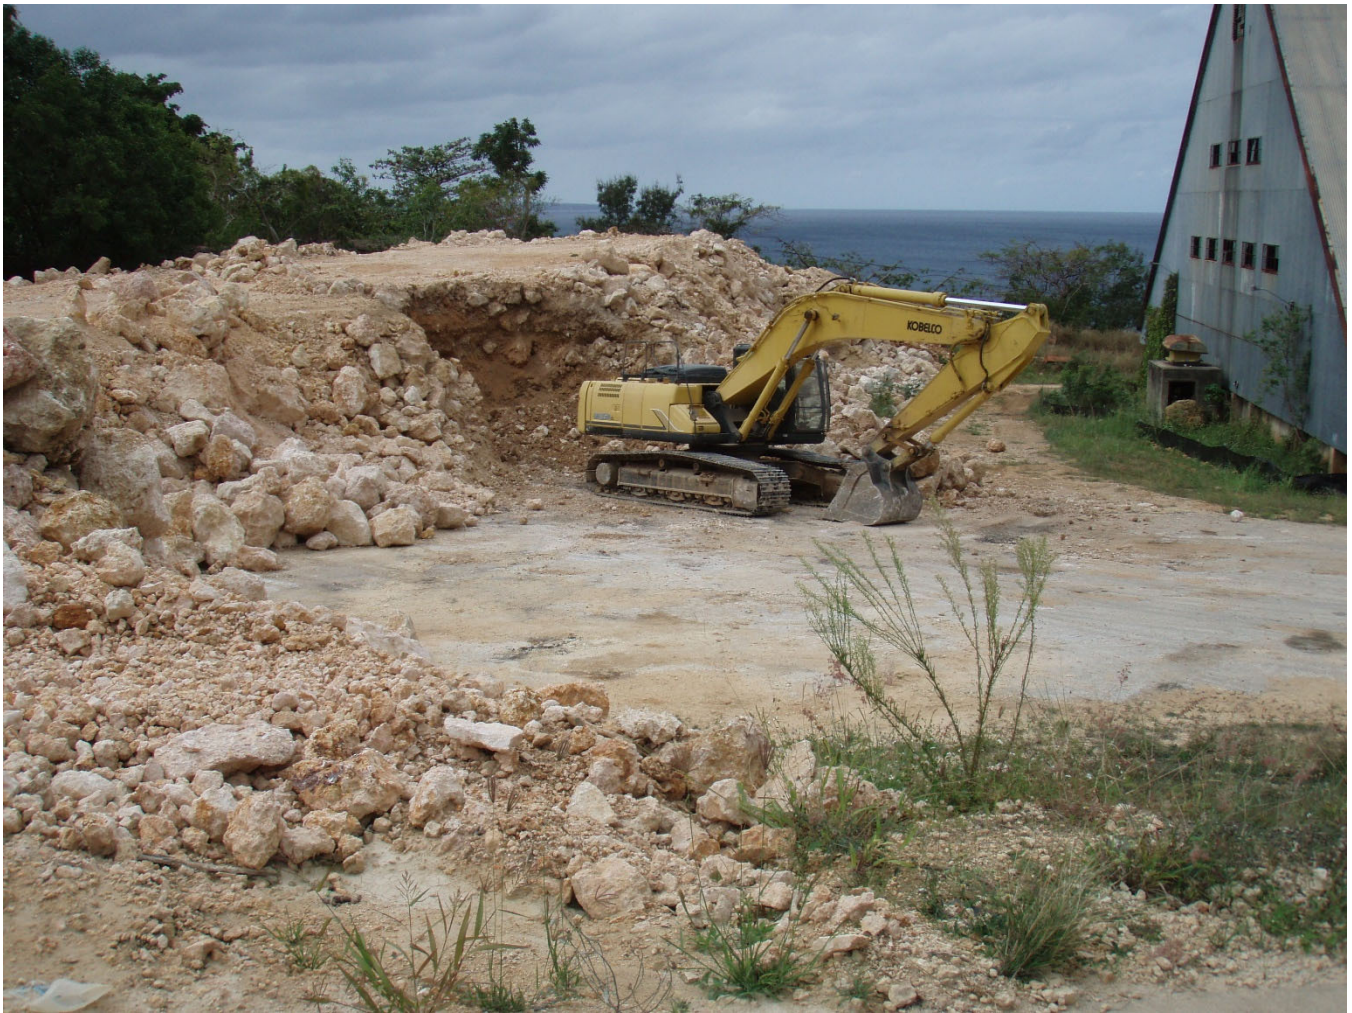
Picture 5
(Nikon Camara: P2221338.JPG; 2/23/23; 10:34 a.m.)

- ✚ This is another view of the stockpile shown in Picture 4, above.
- ✚ No perimeter controls for the stockpile.
- ✚ A portion of the stockpile was removed.
- ✚ An excavator is shown, which is the same one observed in operation during Inspection entry to the Site.

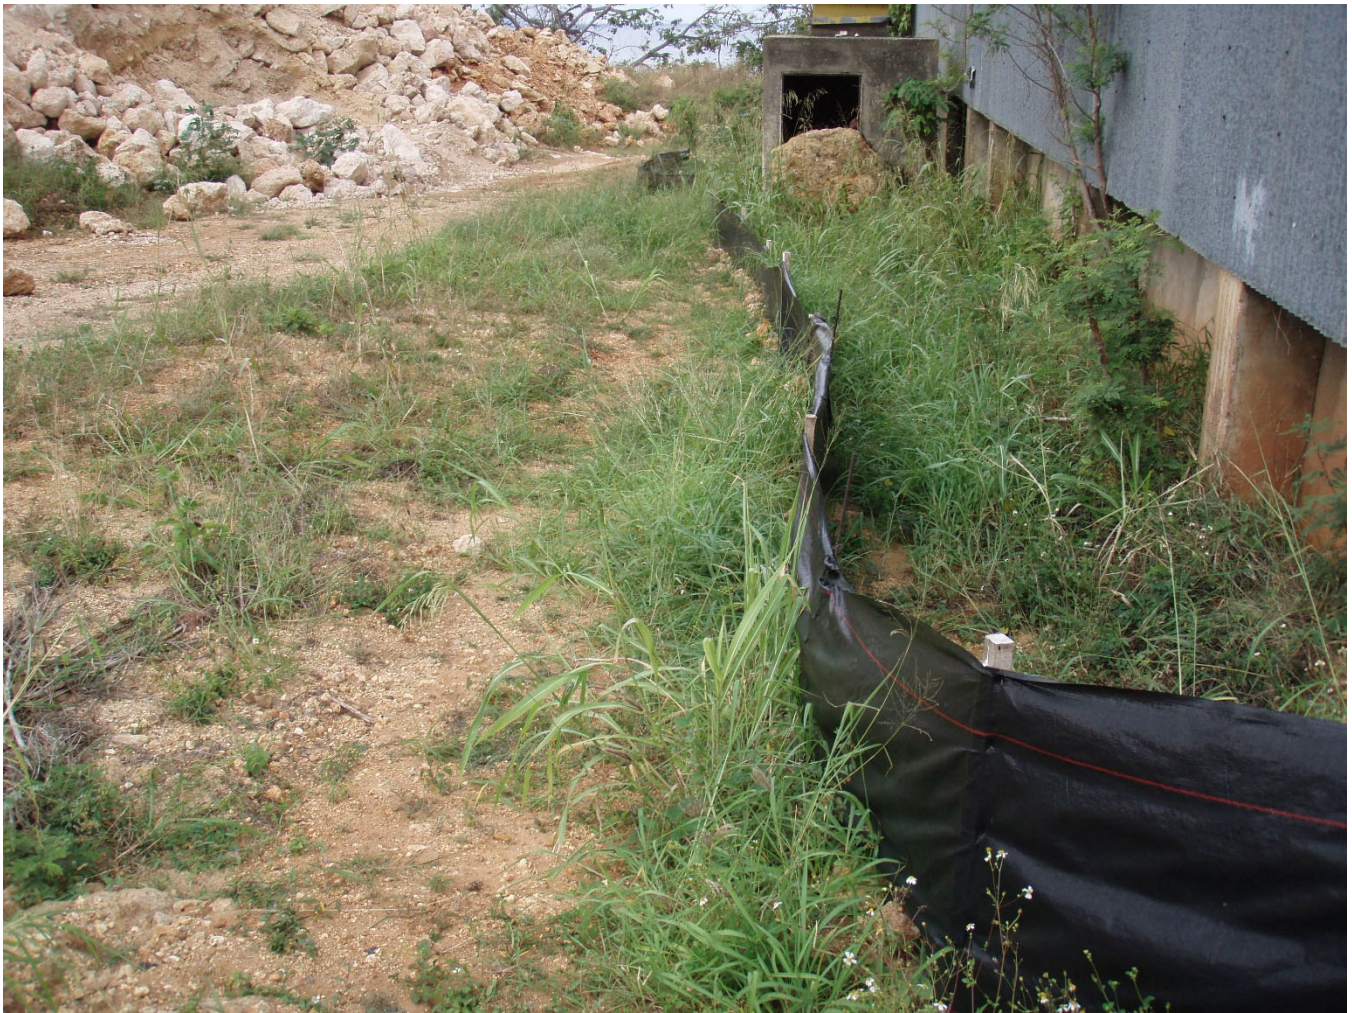
Picture 6
(Nikon Camara: P2221346.JPG; 2/23/23; 10:46 a.m.)

- ✚ This picture depicts areas between the soil stockpile and Warehouse Building.
- ✚ The silt fence was not installed according to installation specifications.

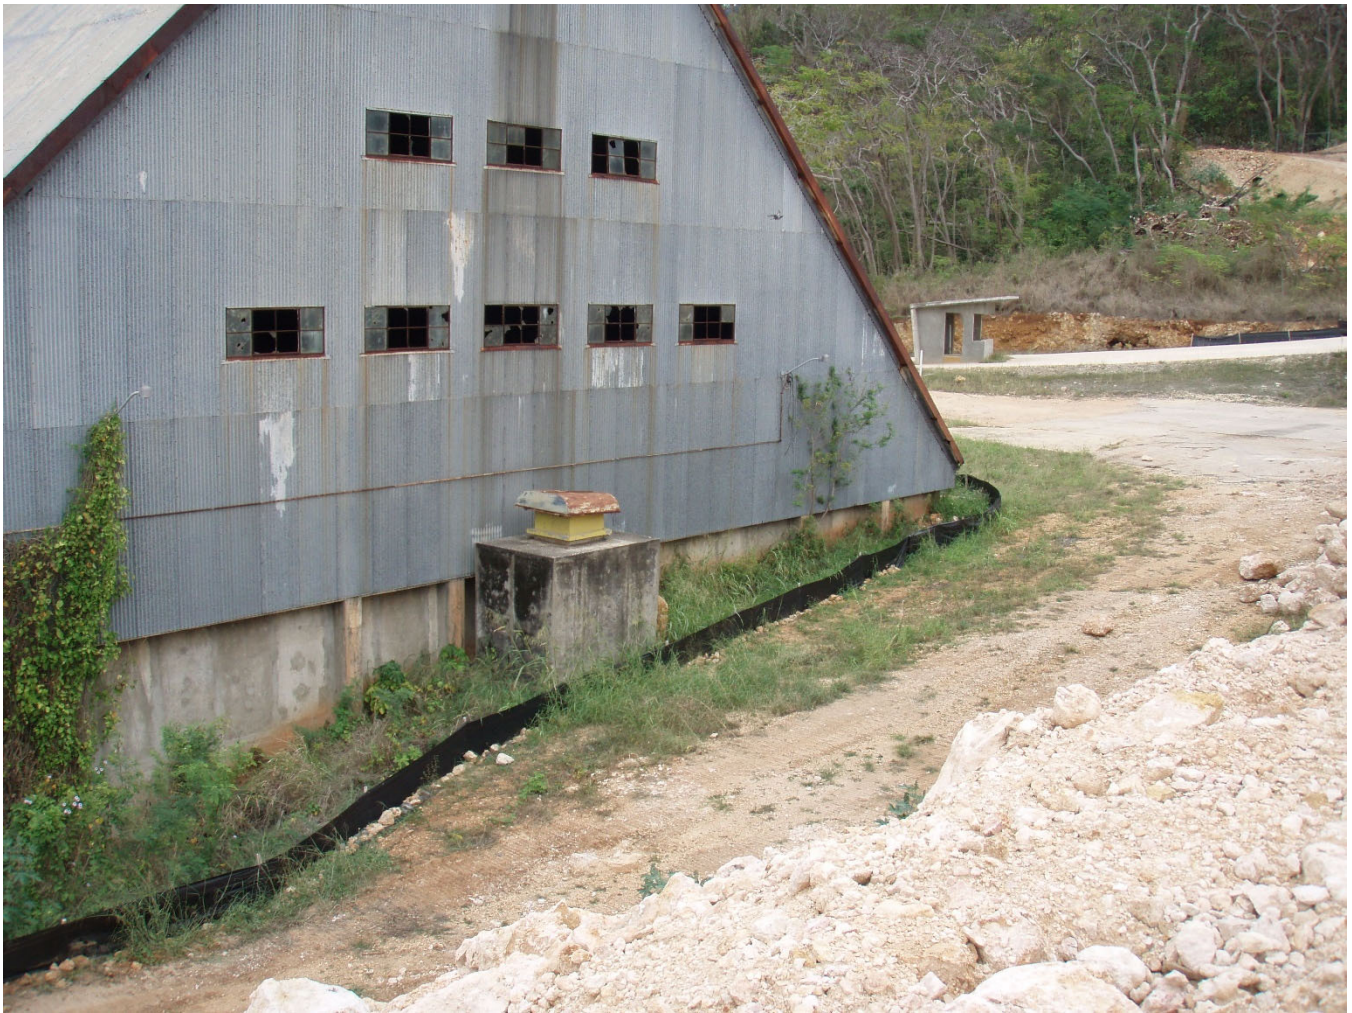
Picture 7
(Nikon Camara: P2221342.JPG; 2/23/23; 10:38 a.m.)

- ✚ This picture also depicts areas near the soil stockpile, a dirt road and Warehouse Building.
- ✚ Soil stabilization controls were not implemented at the dirt road.
- ✚ Refer to comments and observations on Picture 6, above.

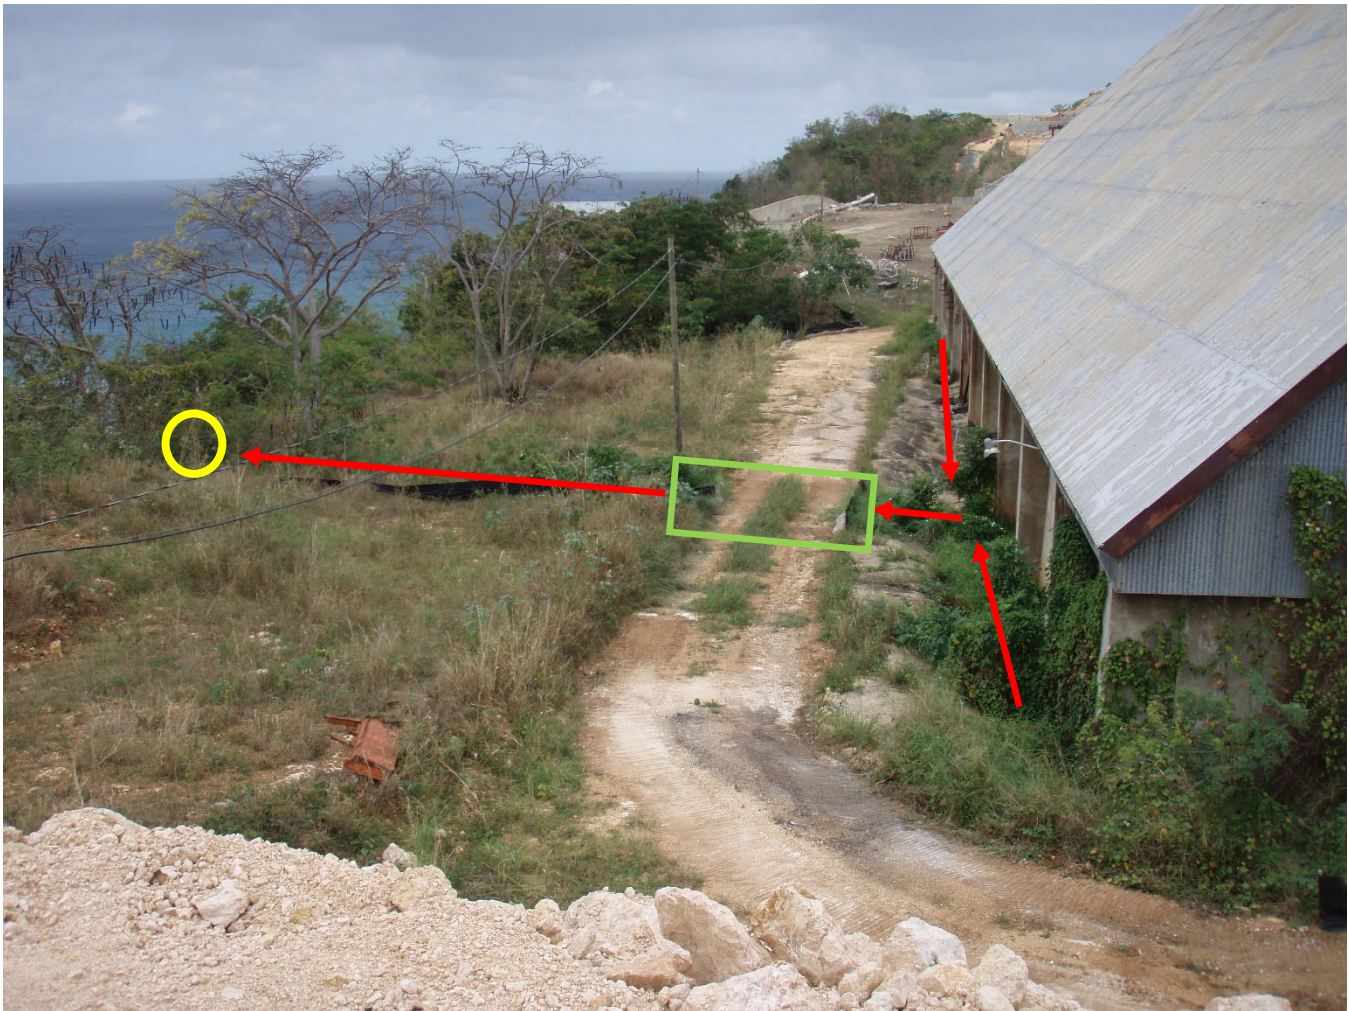
Picture 8
(Nikon Camara: P2221343.JPG; 2/23/23; 10:38 a.m.)

- ✚ This picture depicts areas between the stockpile and west areas of the Warehouse Building.
- ✚ The yellow-colored circle picture depicts the approximate location of Outfall 002. The “Change NOI” indicates “002: Atlantic Ocean Almacén Sur”. The red-colored arrows depict the approximate discrete conveyances and runoff path toward Outfall 002. The green-colored rectangle depicts the approximate location of culvert under the dirt road.
- ✚ Soil stabilization controls were not implemented at the dirt road.
- ✚ Perimeter controls, other than established vegetation, were not implemented for a portion of the soil stockpile.

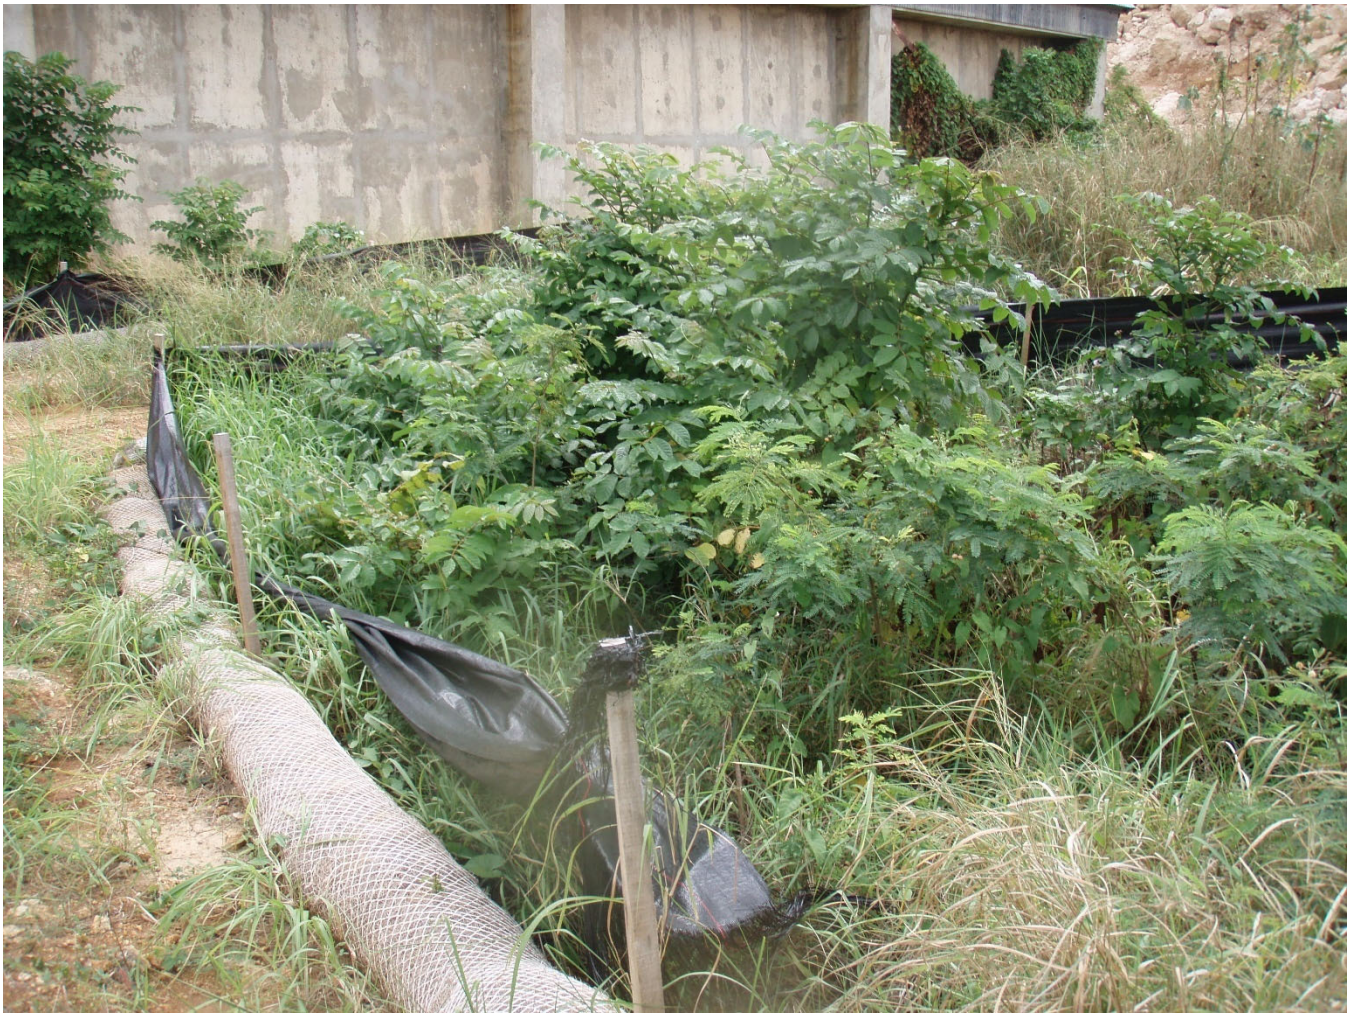
Picture 9

- ✚ The picture depicts a closer view of the west end of the green-colored rectangle shown in Picture 8, above.
- ✚ The silt fence is deteriorated and portions of it were not installed according to installation specifications.

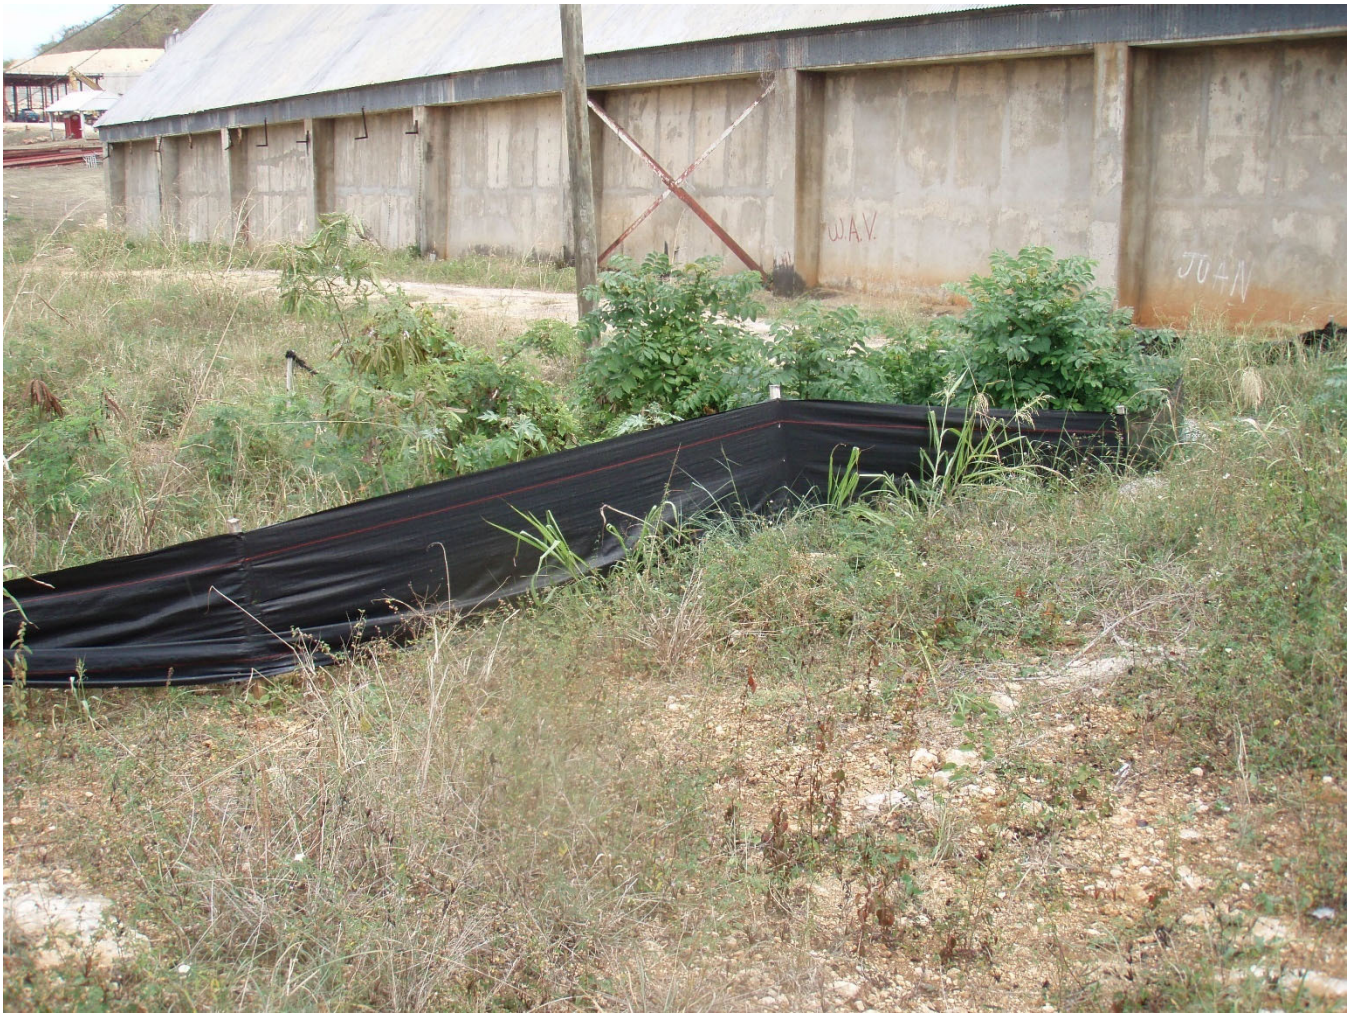
Picture 10
(Nikon Camara: P2221348.JPG; 2/23/23; 10:48 a.m.)

- ✚ The picture depicts another closer view of the west end of the green-colored rectangle shown in Pictures 8, above.
- ✚ The silt fence is deteriorated and portions of it were not installed according to installation specifications.

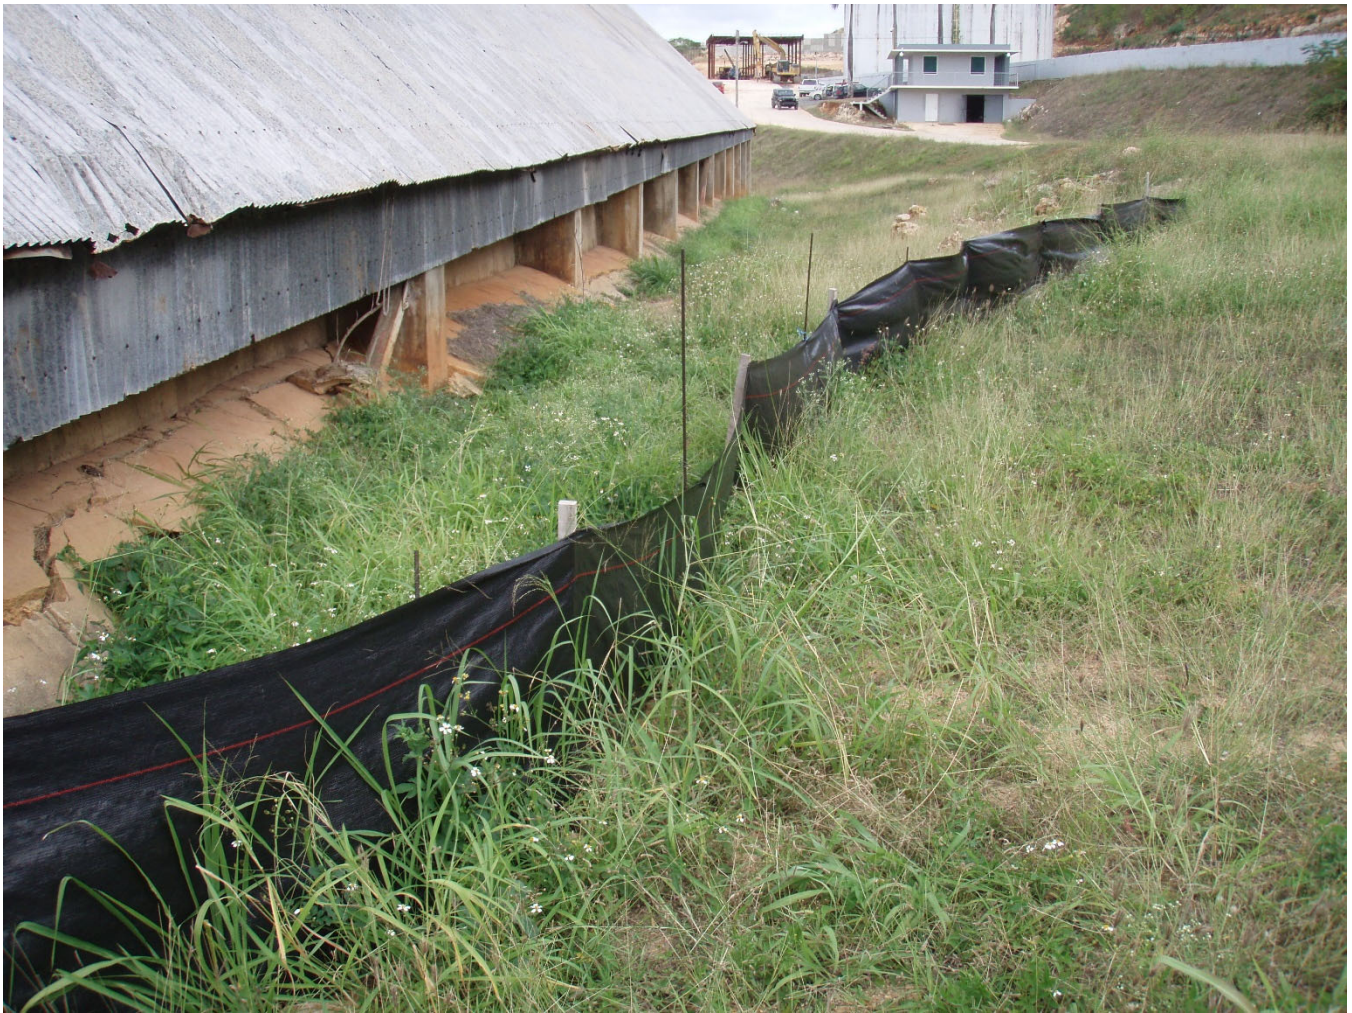
Picture 11
(Nikon Camara: P2221345.JPG; 2/23/23; 10:46 a.m.)

- ✚ The picture depicts areas east of the Warehouse Building covered with vegetation.
- ✚ The silt fence is deteriorated and portions of it were not installed according to installation specifications.

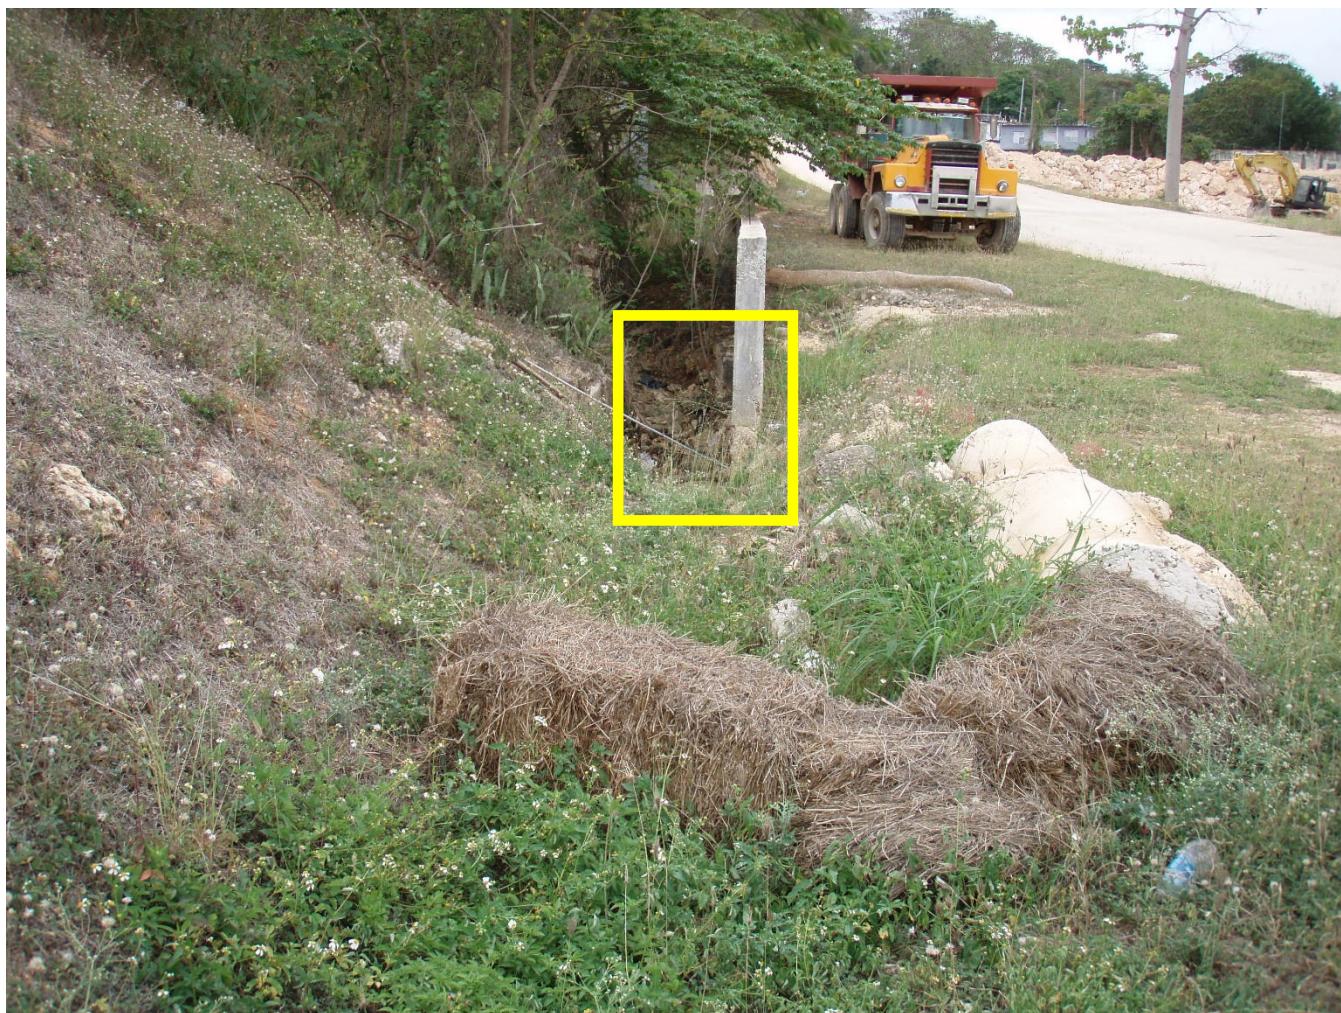
Picture 12

- ✚ This picture depicts the main concrete paved road to the Site, heavy equipment (i.e., excavator, hauling truck) and the soil stockpile.
- ✚ This picture also depicts a yellow-colored rectangle showing the approximate location of an underground conveyance that collects and directs storm water runoff from areas east of the main concrete paved road to the northwest areas near the Warehouse Building. Such areas are depicted on Picture 13 (next page).

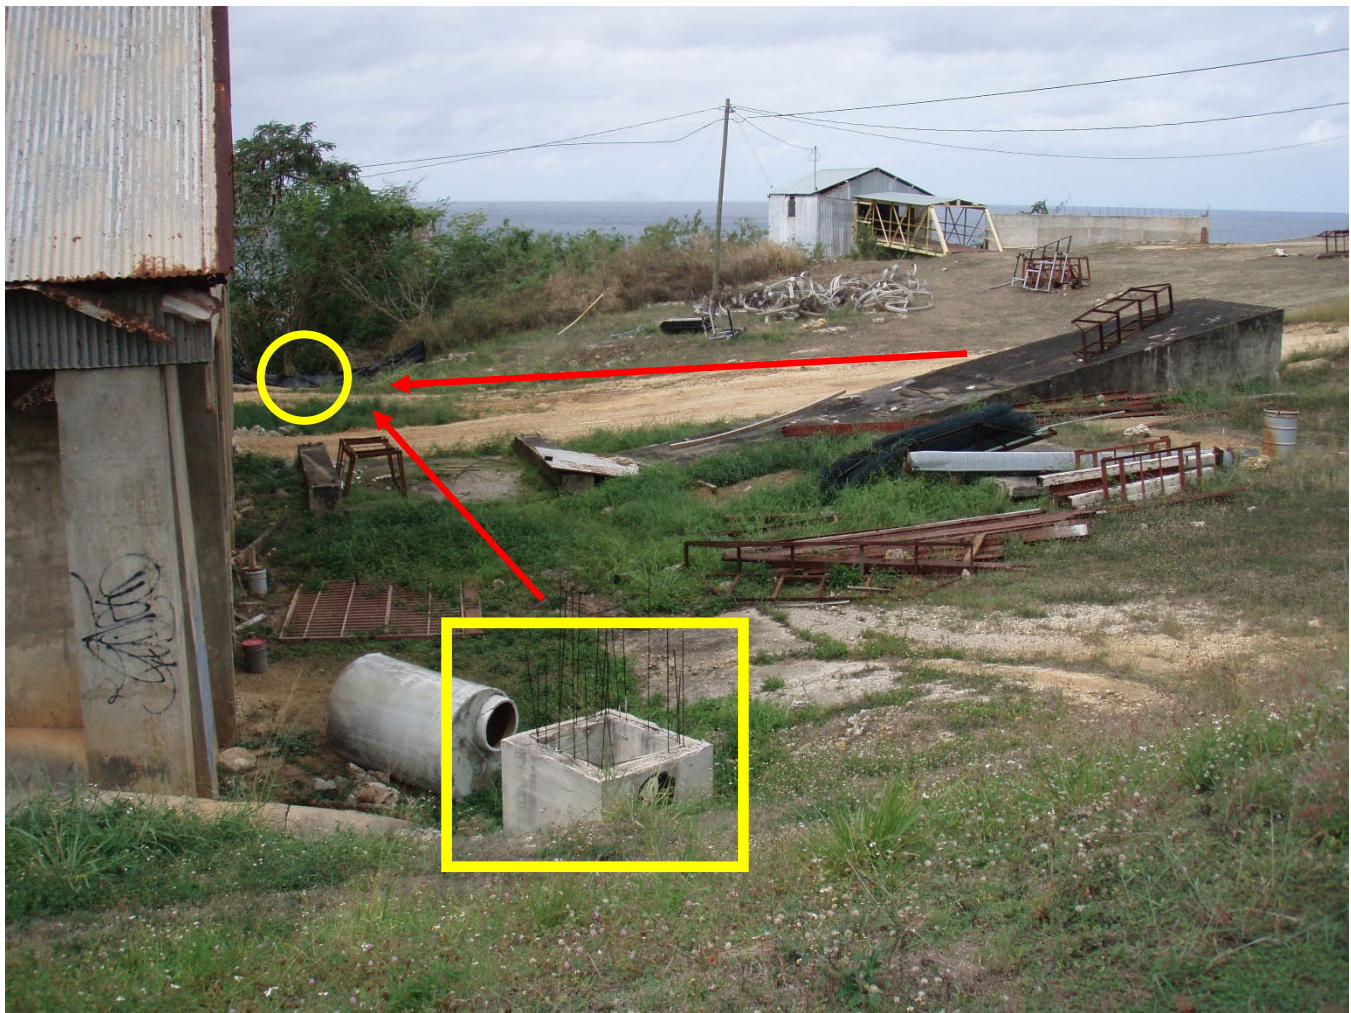
Picture 13
(Nikon Camara: P2221337.JPG; 2/23/23; 10:32 a.m.)

- ✚ This picture depicts a yellow-colored rectangle showing the approximate location of the other side of the underground conveyance shown on Picture 12 (above), which is located on the northeast corner of the Warehouse Building.
- ✚ The red-colored arrows depict the approximate storm water runoff paths towards Outfall 001. The yellow-colored circle depicts the approximate location of Outfall 001. The “Change NOI” indicates “001: Atlantic Ocean Almacén Norte”.
- ✚ Soil stabilization controls not implemented at the dirt road.
- ✚ Established vegetation found in the nearby areas north of the Warehouse Building.
- ✚ Two 5-gallon containers of unknown content exposed to rain.
